Florida Boat & Yacht Surveyors

Marine Infrared Thermographic Inspection

Vessel Name: Sample

Vessel Area Inspected Starboard side forward.

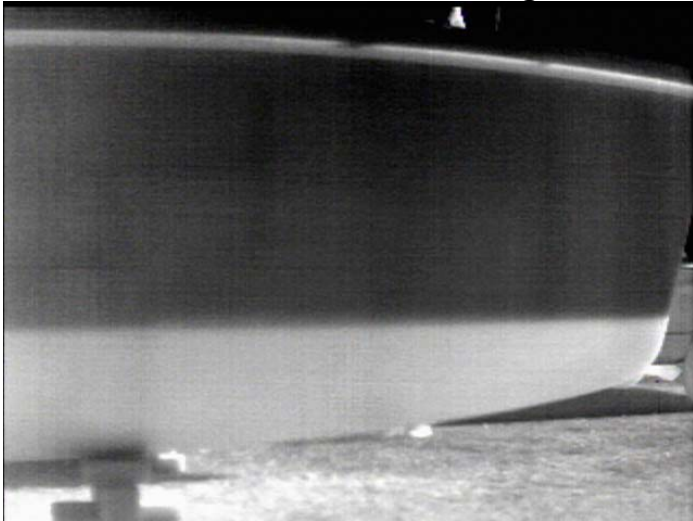
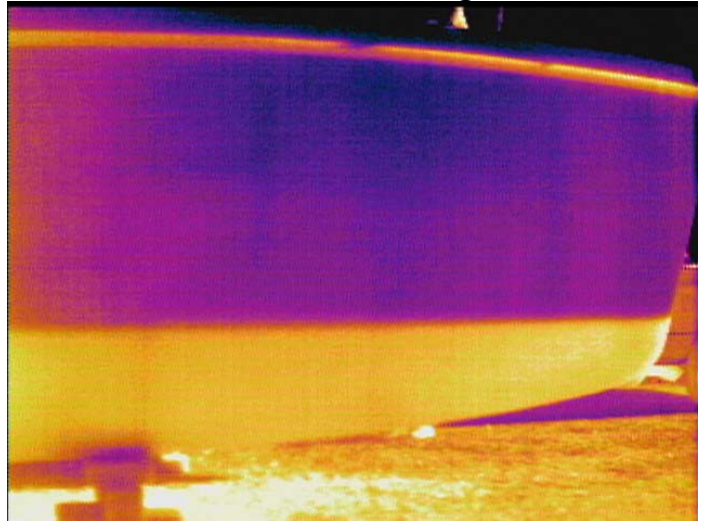
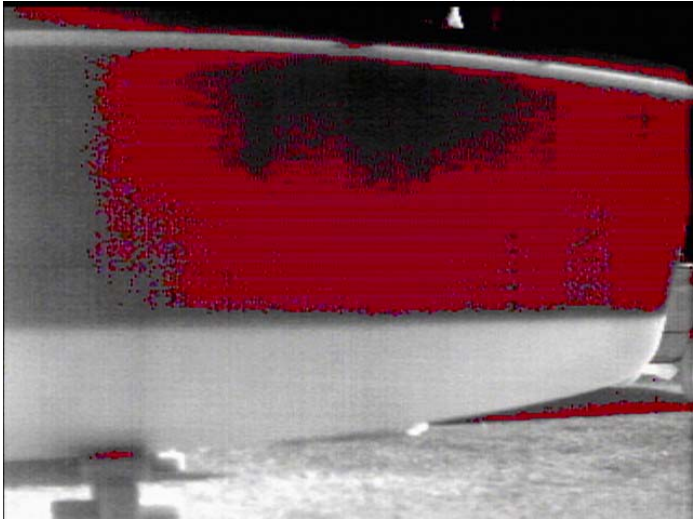
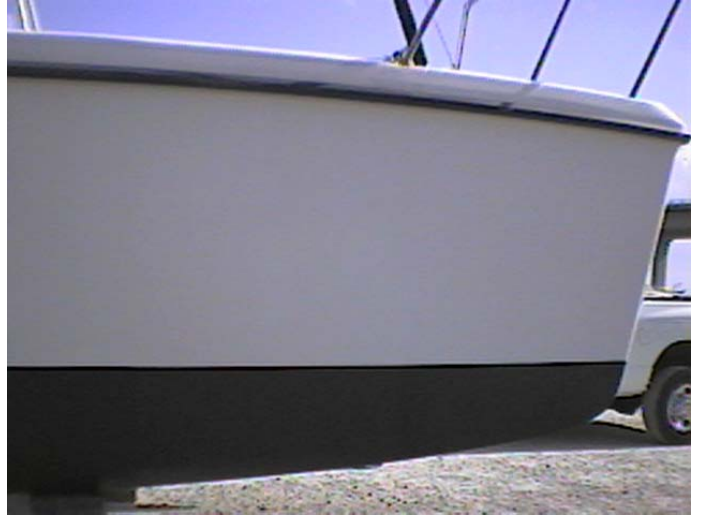
Moisture intrusion into composite laminate appeared to originate from the hull to deck joint.

Seek advice from authorized fiberglass repair technician.
