Marine Infrared Thermographic Inspection

Inspection Date: May 4, 2004

Vessel Name: Sample Vessel

Vessel Area Inspected Stern under swim platform

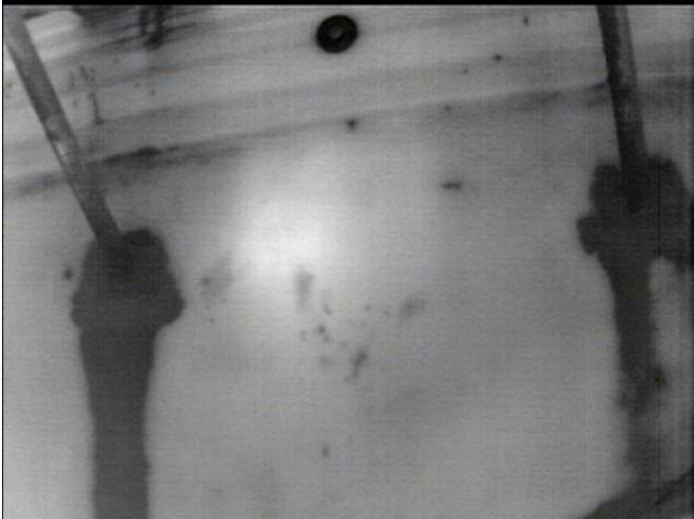
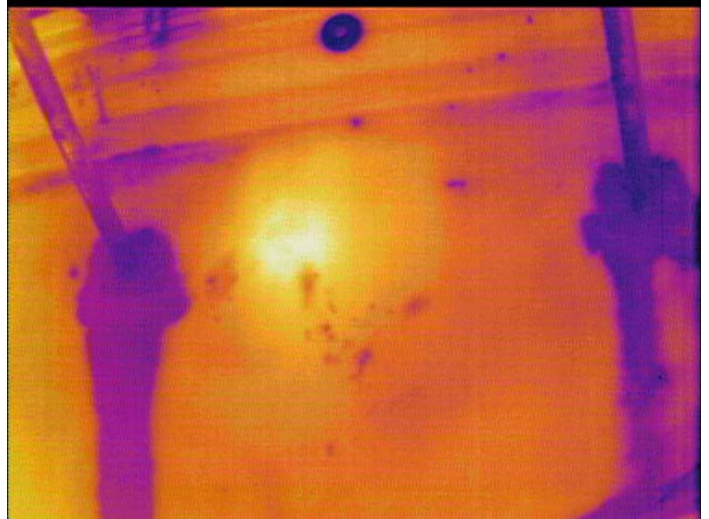
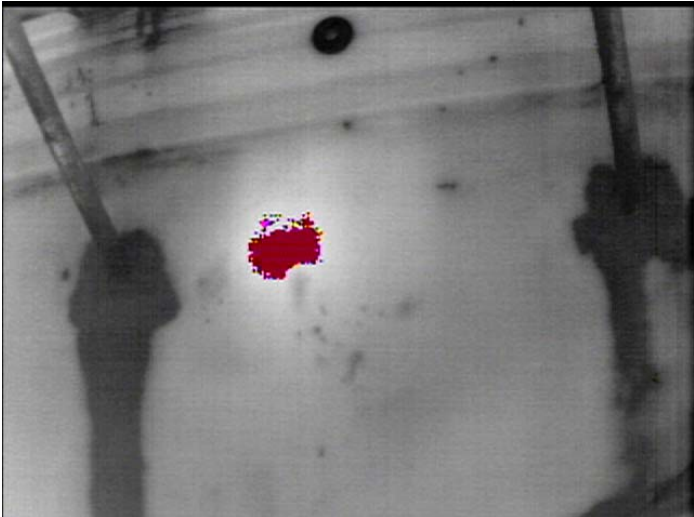
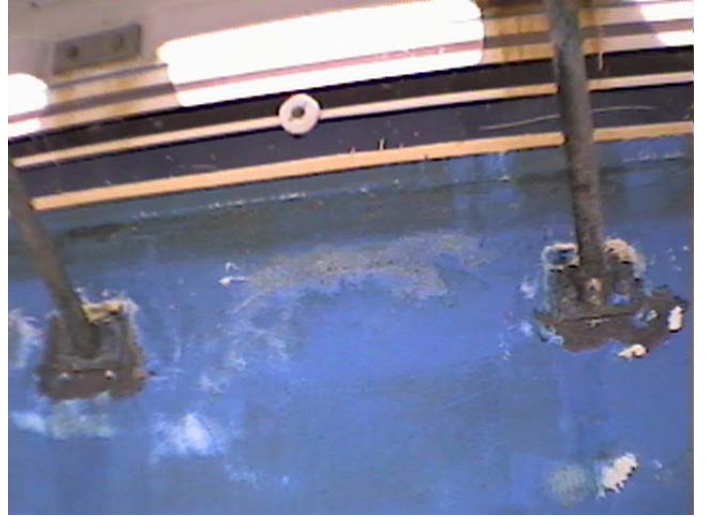
Void in fiberglass reinforced plastic hull at the stern. Stress on the material from the swim platform appears to have contributed to the failure of this structural section of the vessel.

Seek advice from qualified fiberglass repair facility.
