Florida Boat & Yacht Surveyors

Marine Infrared Thermographic Inspection

Vessel Name: Sample Vessel

Vessel Area Inspected Port side above waterline at about mid foredeck.

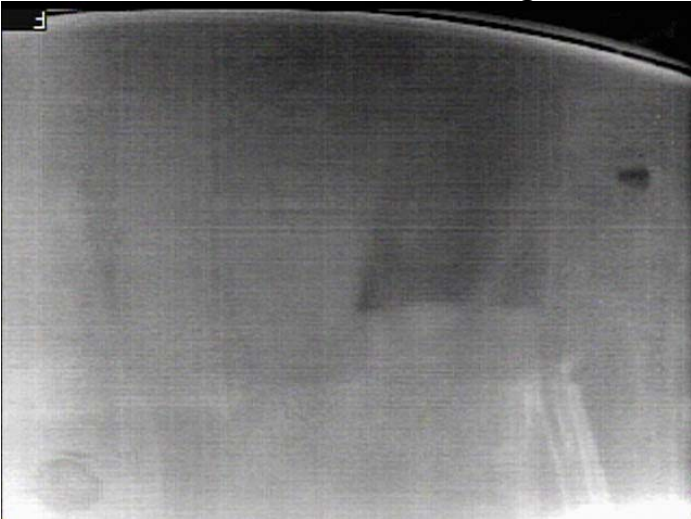
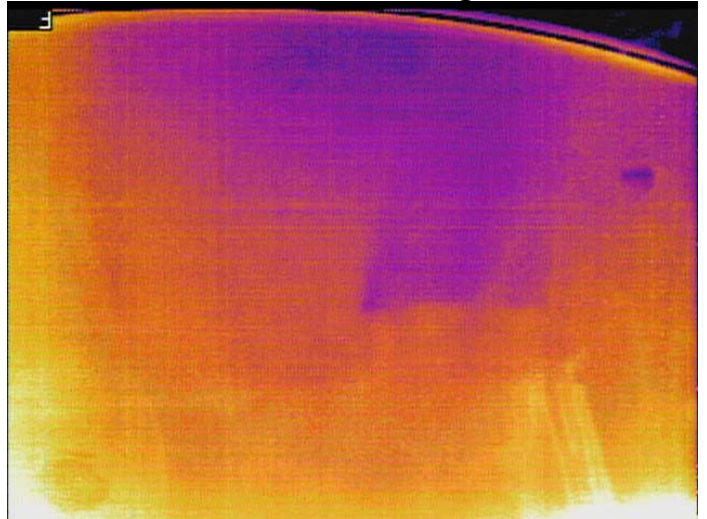
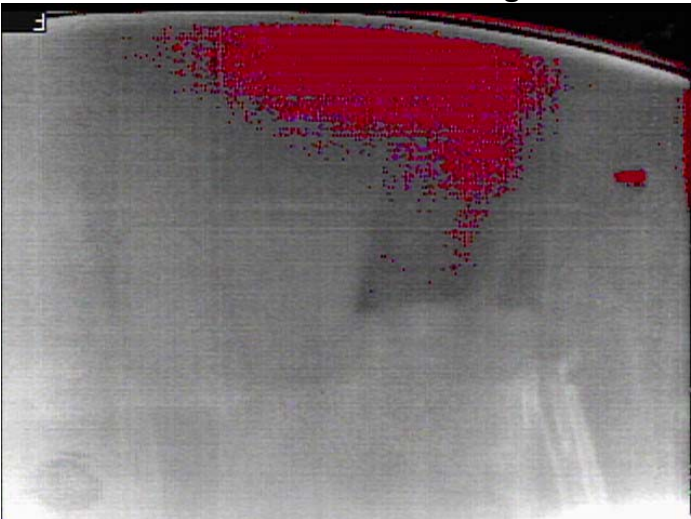
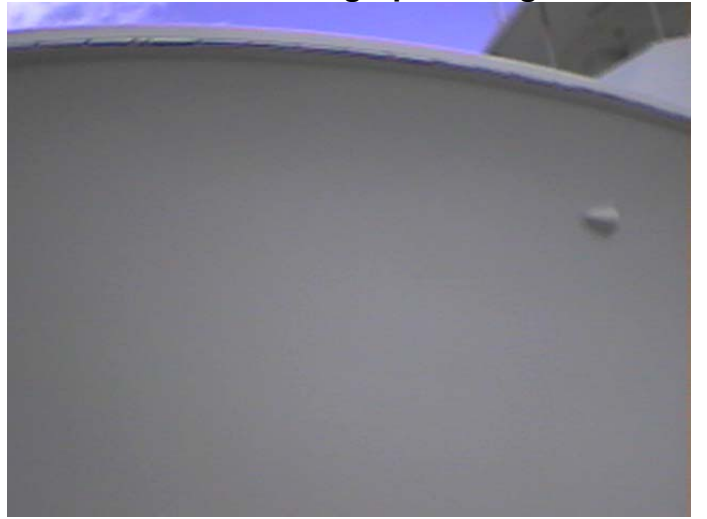
Vessel appeared to have water intrusion into the Fiberglass Reinforced Plastic (FRP) Hull may have been caused by damage to the vessel's rub rail near the bow. The moisture has remained above the waterline in this image. The rub rail does not have any visual signs of damage but some screws appeared to be loose.

Repair and seal the area described above with marine grade materials to prevent water incursion. Monitor area with a moisture meter frequently and follow up in one year with an infrared re-inspection.
