Marine Infrared Thermographic Inspection

Vessel Name: Sample Vessel

Vessel Area Inspected Port side double hull steel gunwale about 6 feet aft of bow.

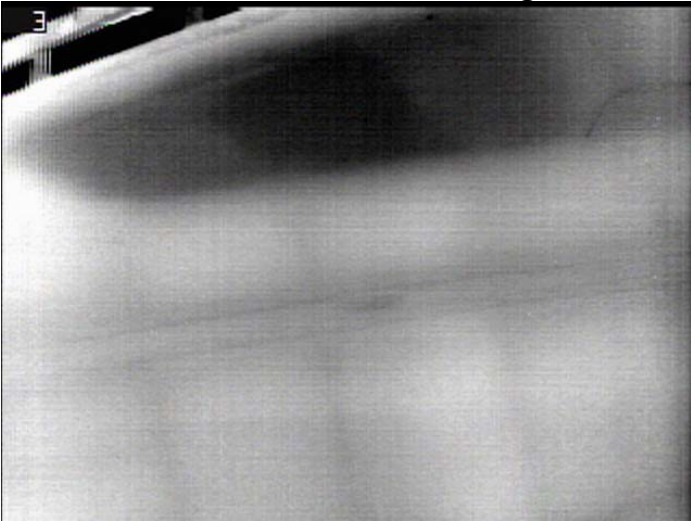
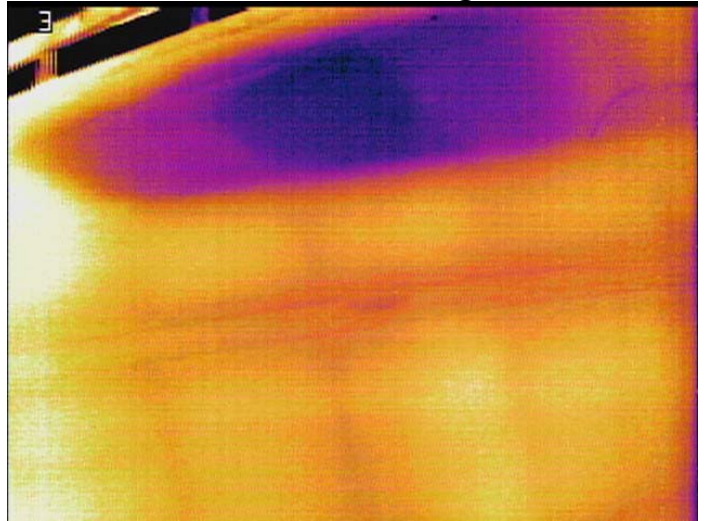
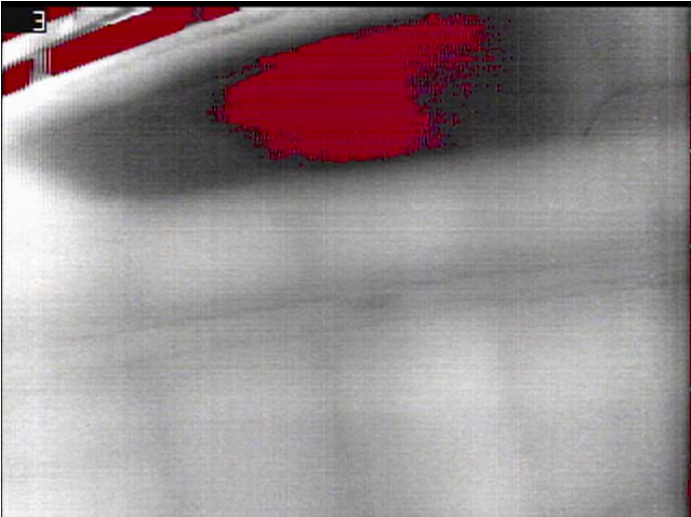
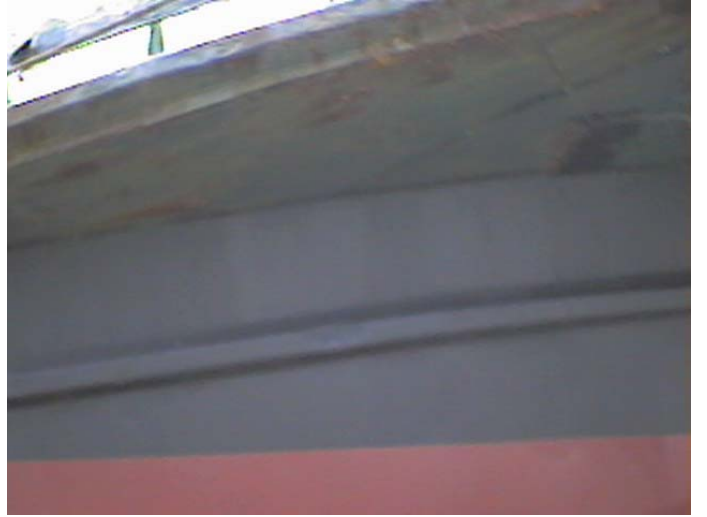
Vessel appeared to have water intrusion through the top steel skin and trapped by the lower steel skin. The deck above the problem area had small cracks that were corroding that were barely visible by eye.

Captain of vessel ordered the area impacted to be drilled underneath and drained. The area was repaired and sealed with marine grade materials.
