# Florida Boat & Yacht Surveyors

## Marine Infrared Thermographic Inspection

Vessel Name: Sample Vessel

Vessel Area Inspected Starboard side from foredeck to cockpit.

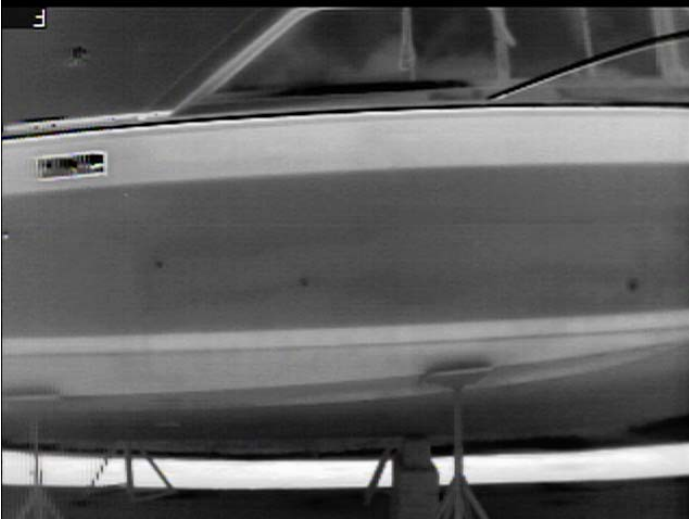
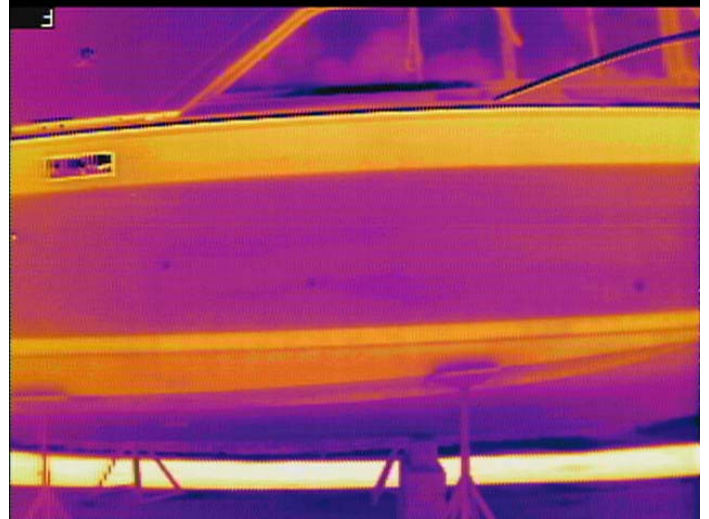
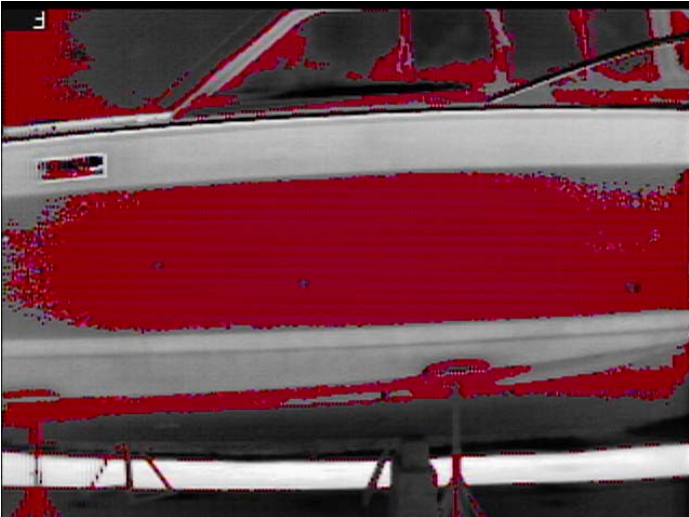
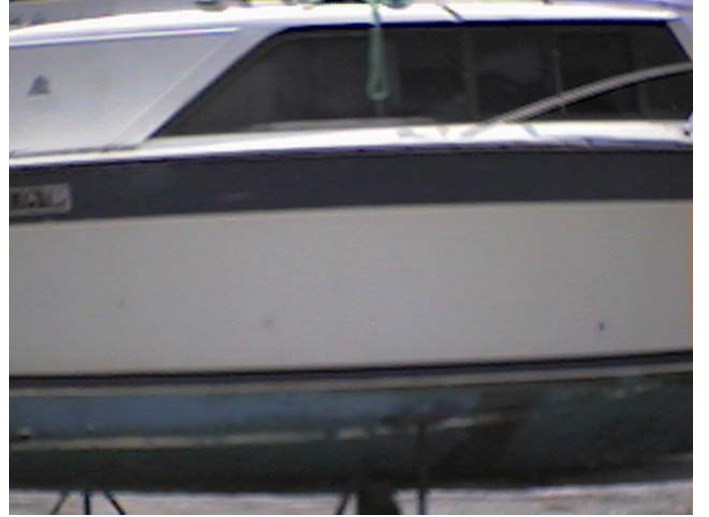
Vessel appeared to have been immersed in water. The vessel owner reported that the vessel had sunk after infrared inspection was completed. The vessel has been drying for two years in drydock. The vessel does not appear to be drying on its own. Vessel has been vaccum bagged and no water was extracted in multiple attempts over the two years in drydock. Owner assumed vessel was dry and ready to repair.

Area impacted by water intrusion is very large in scale and affects most of the vessel. The vessel should be moved to an indoor drying facility to attempt to extract the moisture. If this moisture extraction is unsuccessful, the hull should be considered totaled.
