Marine Infrared Thermographic Inspection

Vessel Name: Sample Vessel

Vessel Area Inspected Port side hull between turn of the bilge and the keel at midship.

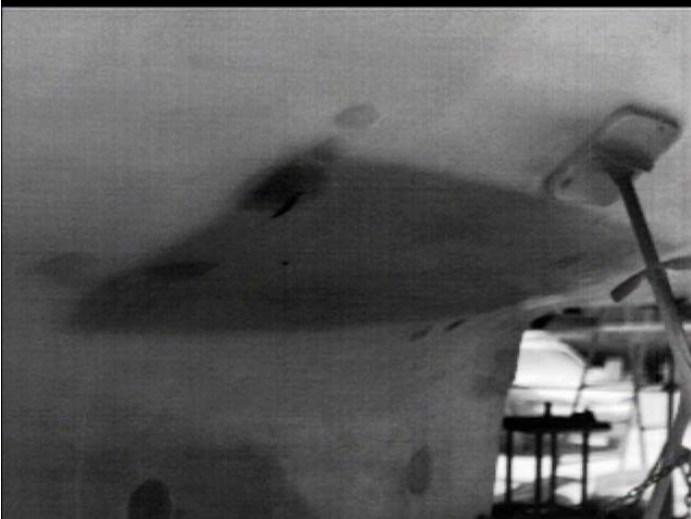
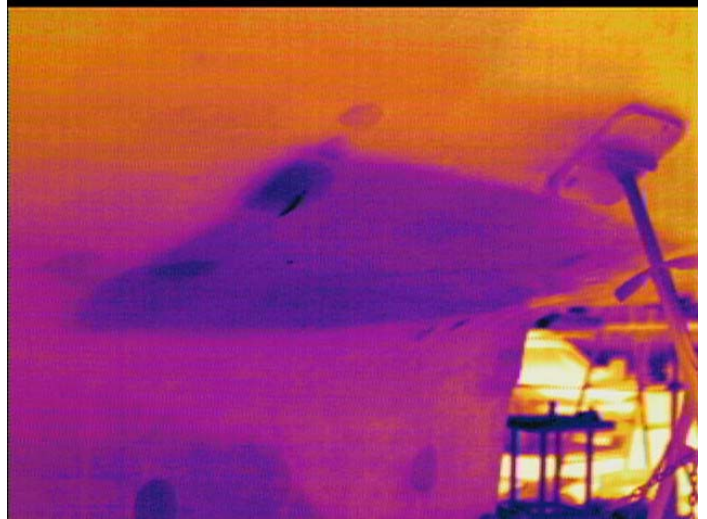
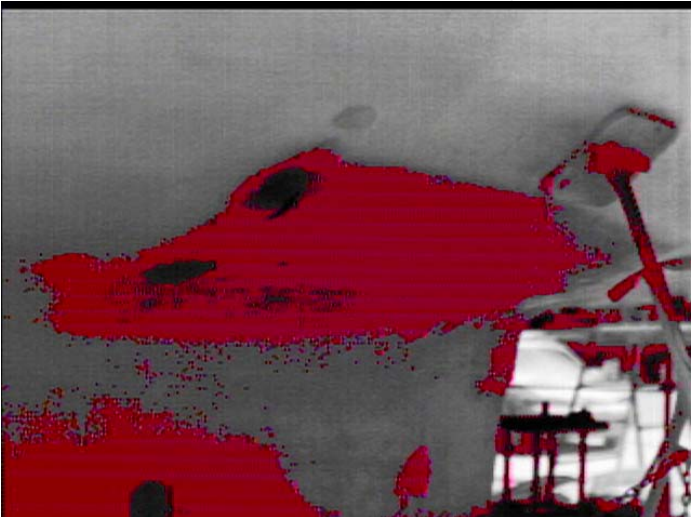
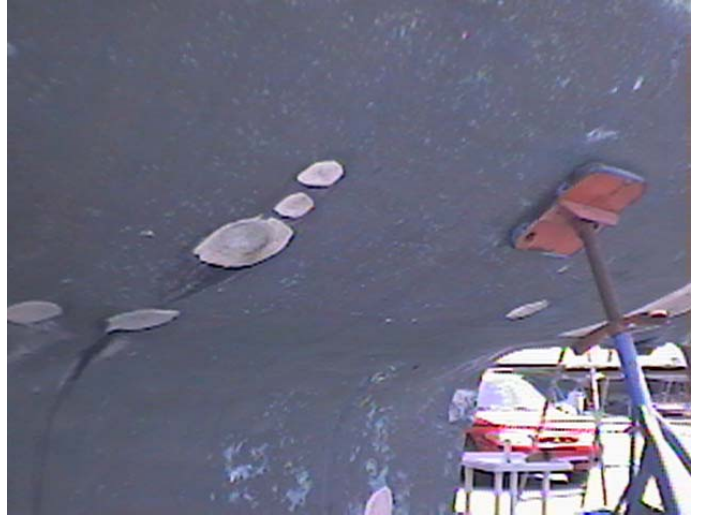
Moisture intrusion into delaminated section of the hulls wetted surface area.

Seek advice from qualified fiberglass repair facility.
