**1999 50' Sea Ray 500 Sundancer**

**FAST SHIP**

# **REPORT OF MARINE SURVEY**

**OF THE VESSEL**

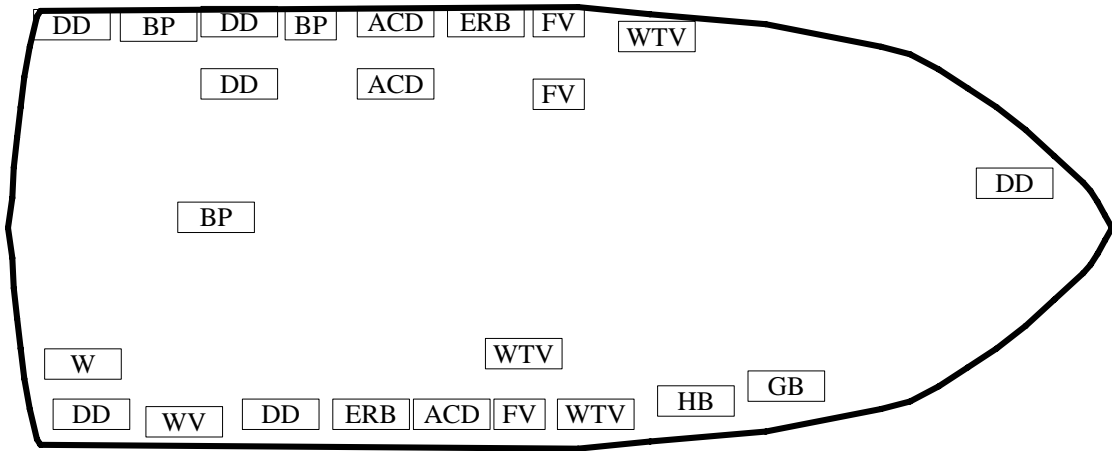
THRU-HULLS ABOVE WATER LINE (DIAGRAM):

<input type="checkbox"/> BP	<input type="checkbox"/> EP	<input type="checkbox"/> ACD	<input type="checkbox"/> DF	<input type="checkbox"/> FV	<input type="checkbox"/> VH	<input type="checkbox"/> ☒
Bilge Pumps	Exhst Ports	AC Dischg	Deck Fill	Fuel Vent	Vent Hose	Inoperable
<input type="checkbox"/> DD	<input type="checkbox"/> ERB	<input type="checkbox"/> WV	<input type="checkbox"/> W	<input type="checkbox"/> WTV	<input type="checkbox"/> HB	<input type="checkbox"/> GB
Deck Drain	Eng Room Blower	Waste Vent	Waste	Water Vent	Head Blower	Galley Blower

THRU-HULL FITTINGS:  
The thru-hull fittings as well as all sighted underwater fittings are bonded where sighted and show no excessive corrosion. The corrosion meter test shows that the through hull fitting are properly protected.

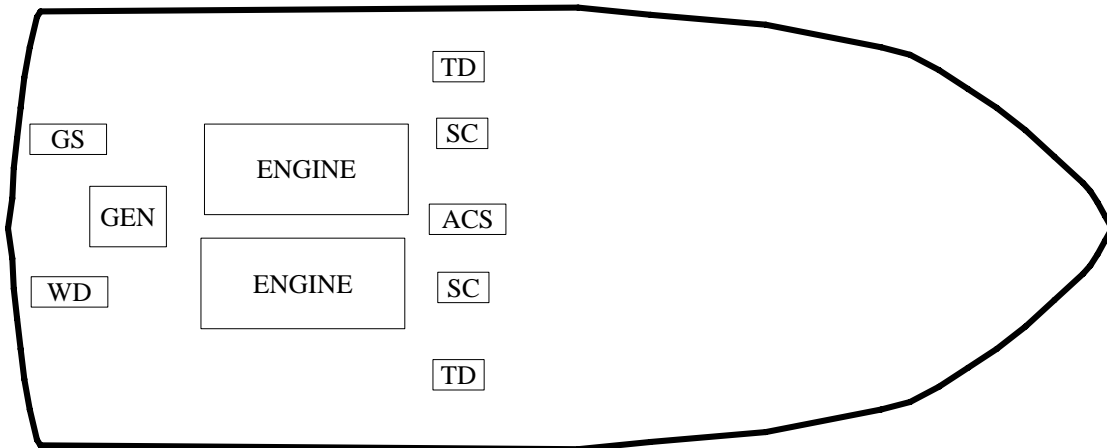
THRU-HULLS BELOW WATER LINE (DIAGRAM):

**NOTE:**

The below the water line thru-hull valves on this vessel were seacocks and were all operable.
